L1358070001 – Montgomery
Eagle Zinc Company
ILD 930606941
SF/HRS

**CERCLA
EXPANDED SITE INSPECTION ADDENDUM REPORT**

Eagle Zinc Company

September 1, 2005

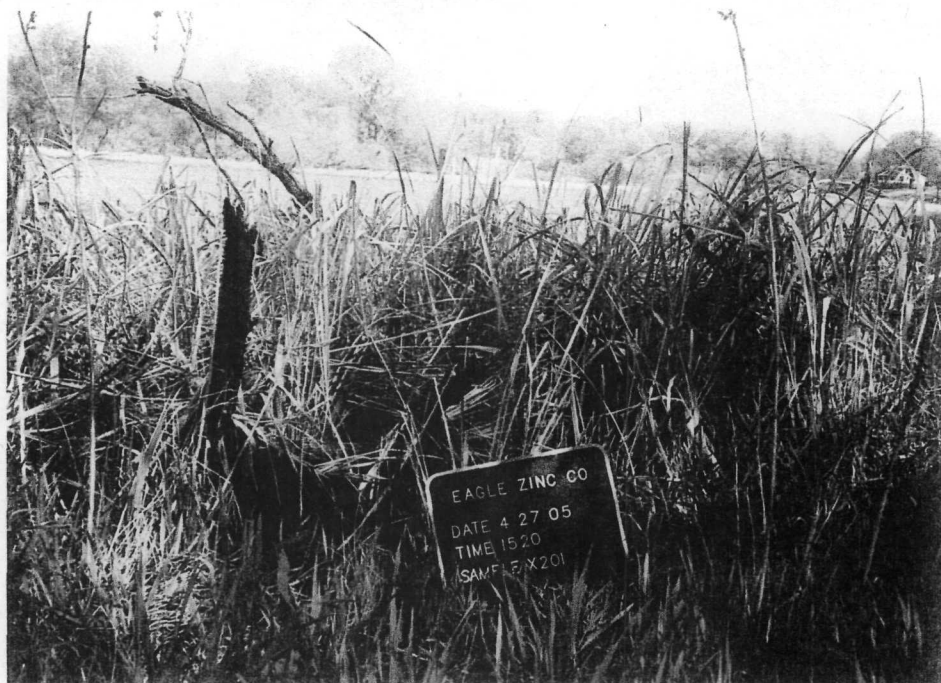
DATE: 4/27/05
TIME: 15:20
PHOTOGRAPH TAKEN BY: R. CASPER
COMMENTS: Picture taken toward: South.
Photo Number 63.
Sample X201. The sample consisted of a brownish gray silty clay collected at a depth of 2 to 4 inches.

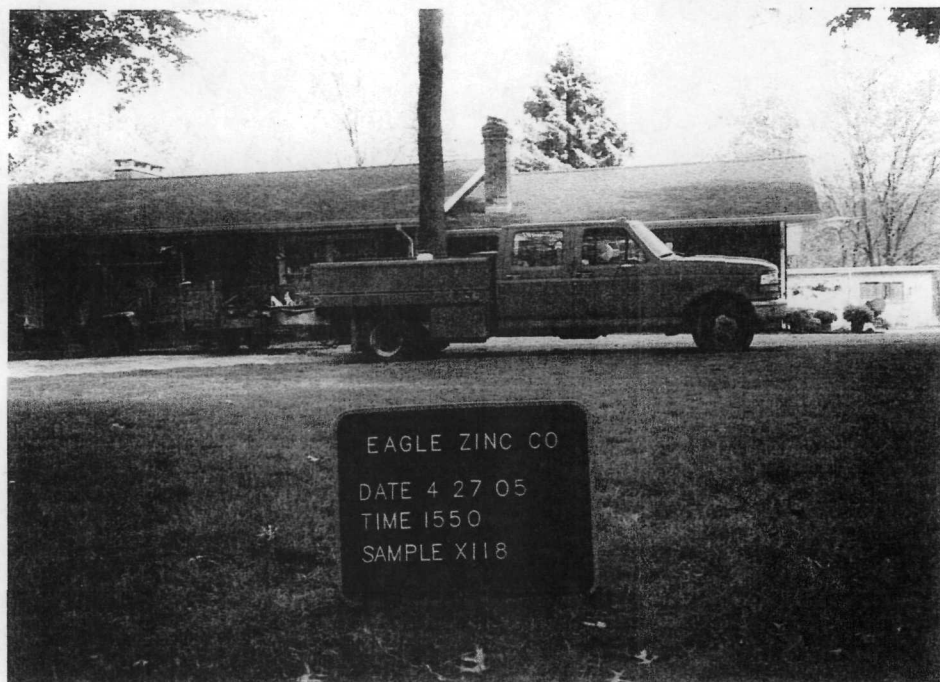
DATE: 4/27/05
TIME: 15:50
PHOTOGRAPH TAKEN BY: R. CASPER
COMMENTS: Picture taken toward: West.
Photo Number 65.
Sample X118. The sample consisted of a dark brown silty loam collected at a depth of 1 to 3 inches.

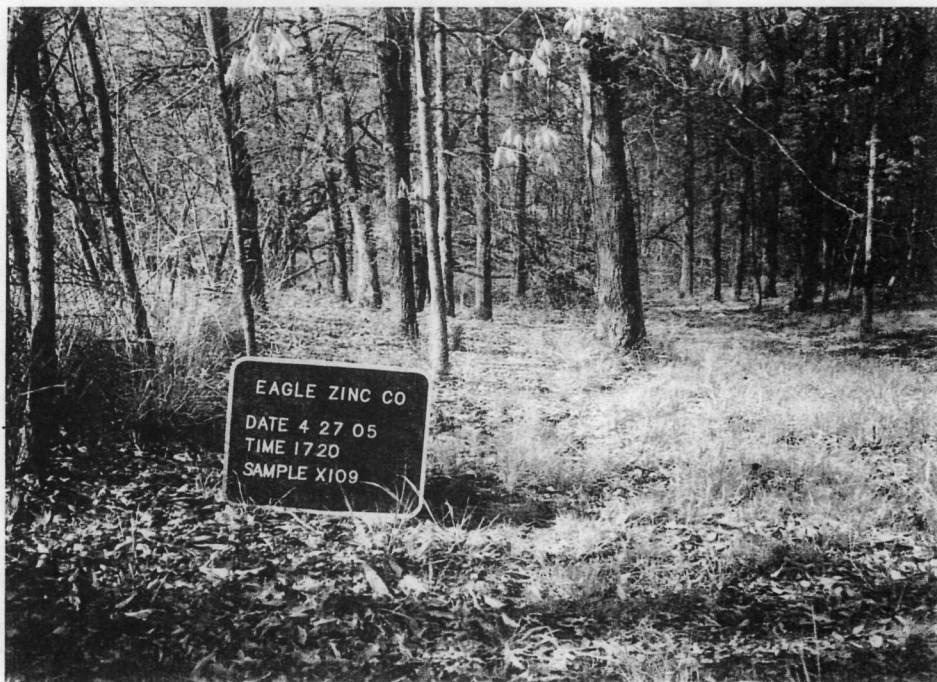
DATE: 4/27/05
TIME: 17:20
PHOTOGRAPH TAKEN BY: R. CASPER
COMMENTS: Picture taken toward: East.
Photo Number 67.
Sample X109. The sample consisted of a brown silty clay collected at a depth of 0 to 2 inches.

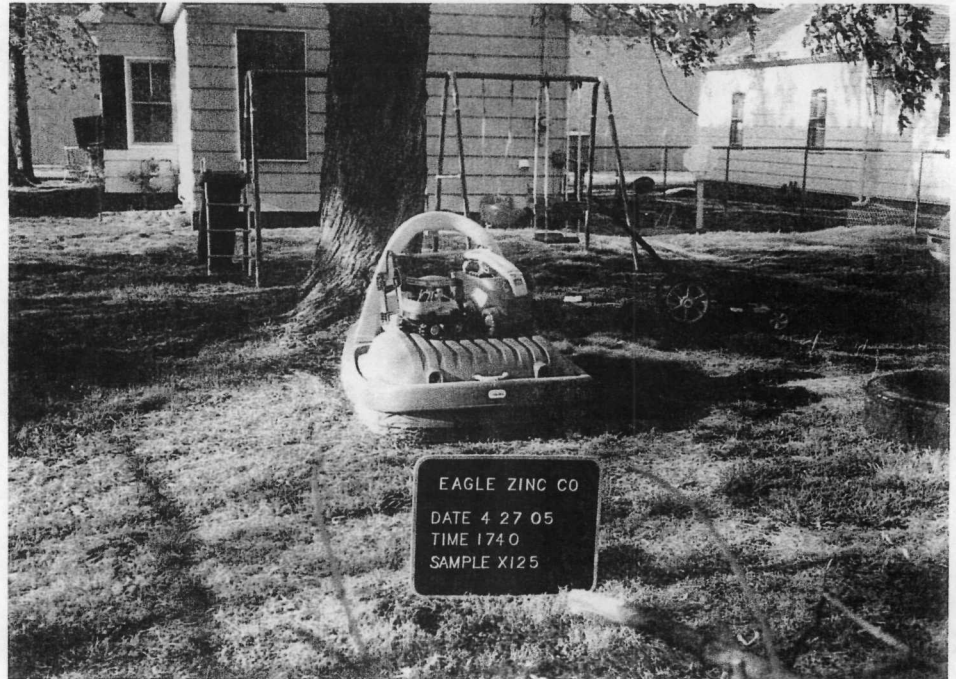
DATE: 4/27/05
TIME: 17:40
PHOTOGRAPH TAKEN BY: R. CASPER
COMMENTS: Picture taken toward: South.
Photo Number 69.
Sample X125. The sample consisted of a black loam with gravel collected at depth of 0 to 3 inches.

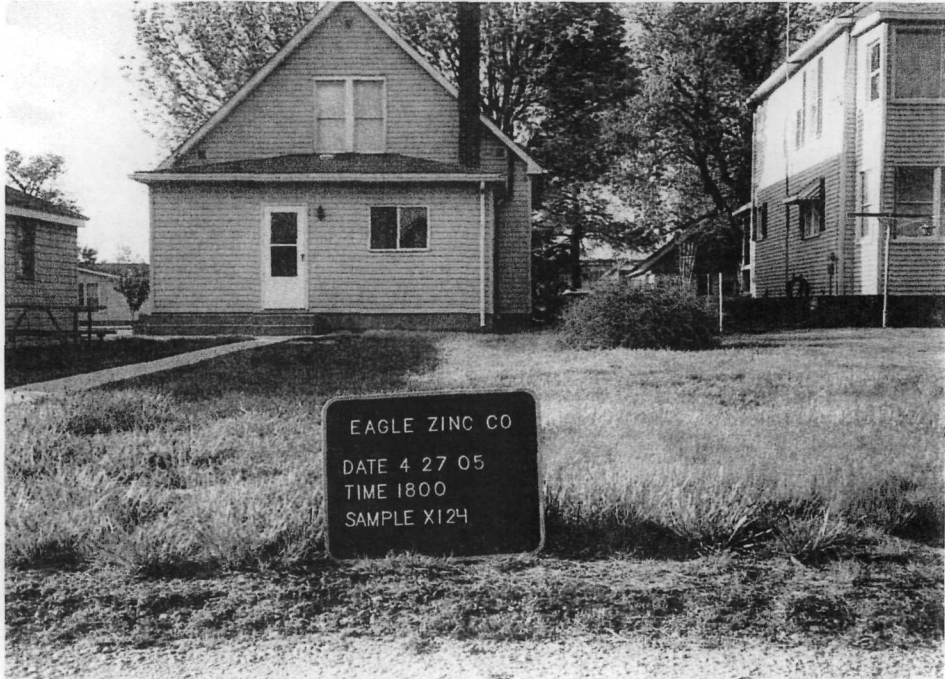
COMMENTS: Picture taken toward: North.		
Photo Number 70.		
Sample X124 was collected from a residential yard southeast of the site.

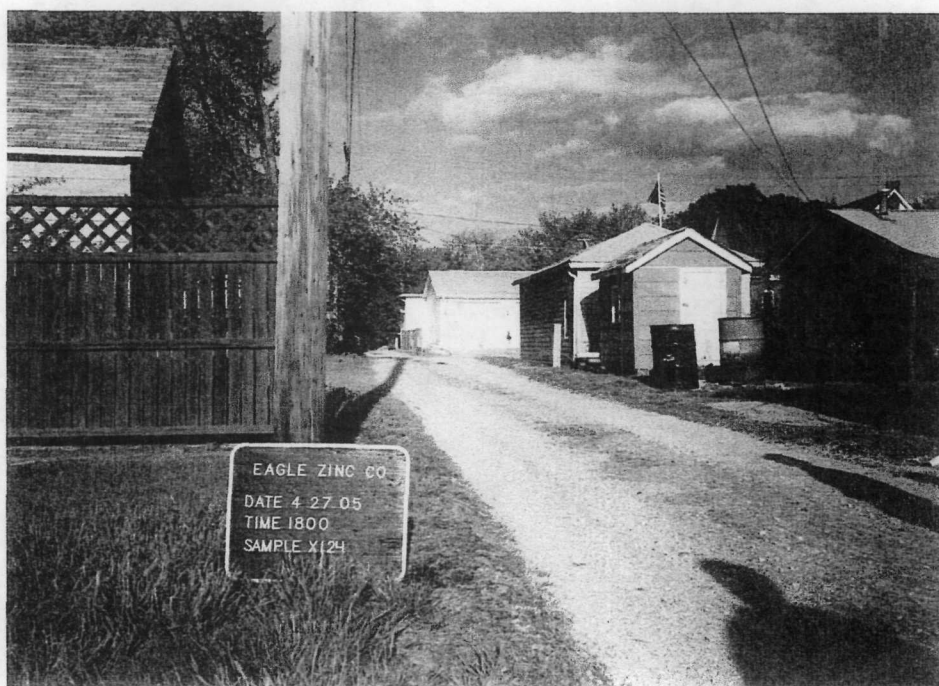
DATE: 4/27/05
TIME: 18:00
PHOTOGRAPH TAKEN BY: R. CASPER
COMMENTS: Picture taken toward: East.
Photo Number 71.
Sample X124. The sample consisted of a fine black slag material.
Collected at depth of 3 to 6 inches.

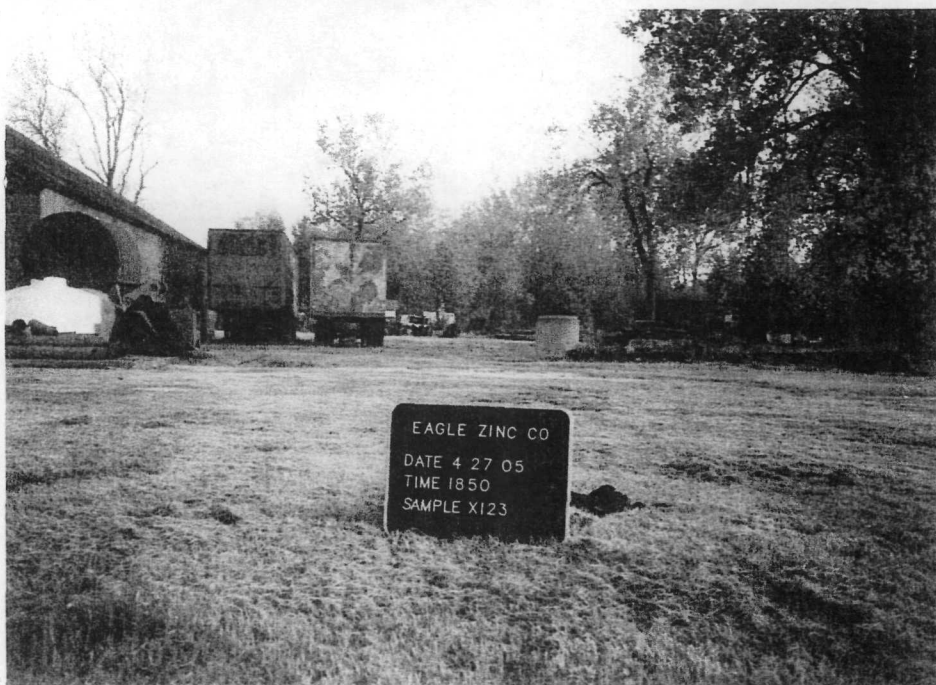
DATE: 4/27/05
TIME: 18:50
PHOTOGRAPH TAKEN BY: R. CASPER
COMMENTS: Picture taken toward: East.
Photo Number 73.
Sample X123. The sample consisted of a black silty loam with cinders collected at depth of 0 to 3 inch.

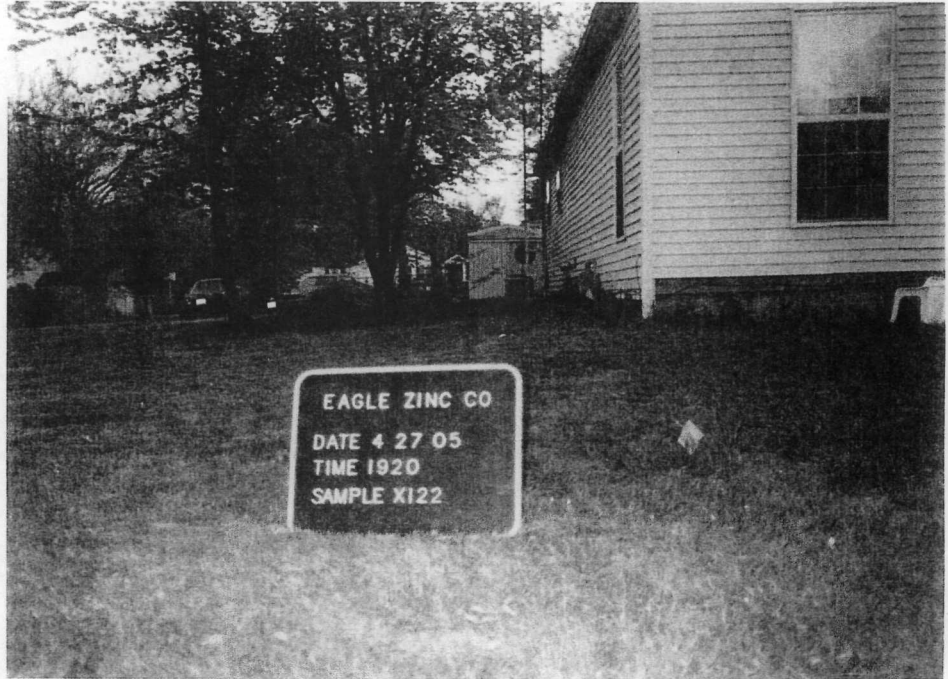
DATE: 4/27/05
TIME: 19:20
PHOTOGRAPH TAKEN BY: R. CASPER
COMMENTS: Picture taken toward: East.
Photo Number 75.
Sample X122. The
sample consisted
of a brown silty
loam collected at
a depth of 2 to 3
inches.

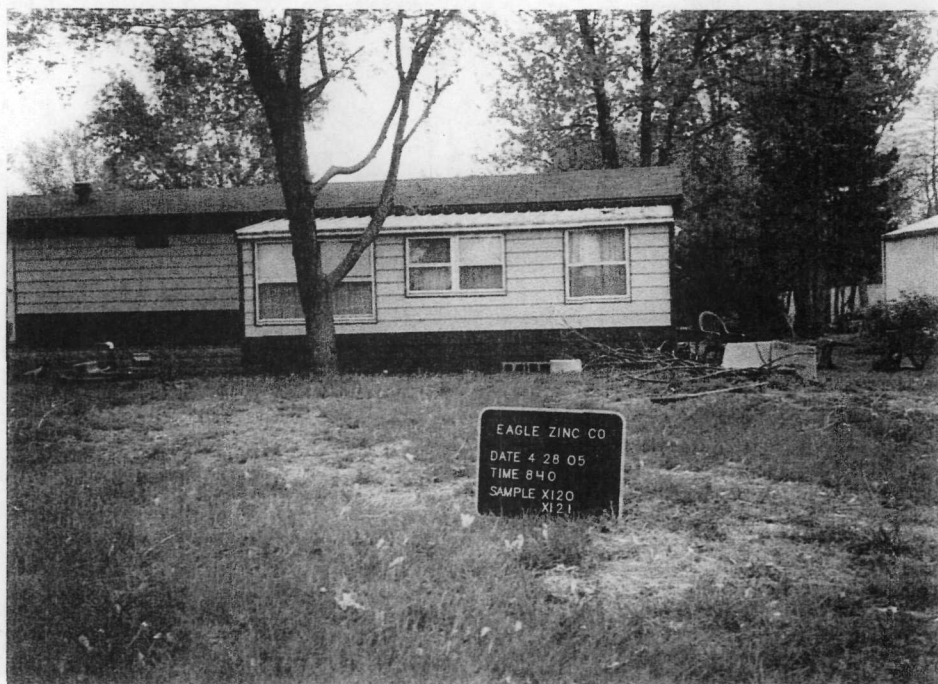
DATE: 4/28/05
TIME: 8:40
PHOTOGRAPH TAKEN BY: R. CASPER
COMMENTS: Picture taken toward: North.
Photo Number 77.
Duplicate samples
X120/X121 consisted
of a light brown
silty clay collect-
ed at a depth of
0 to 1 inch.

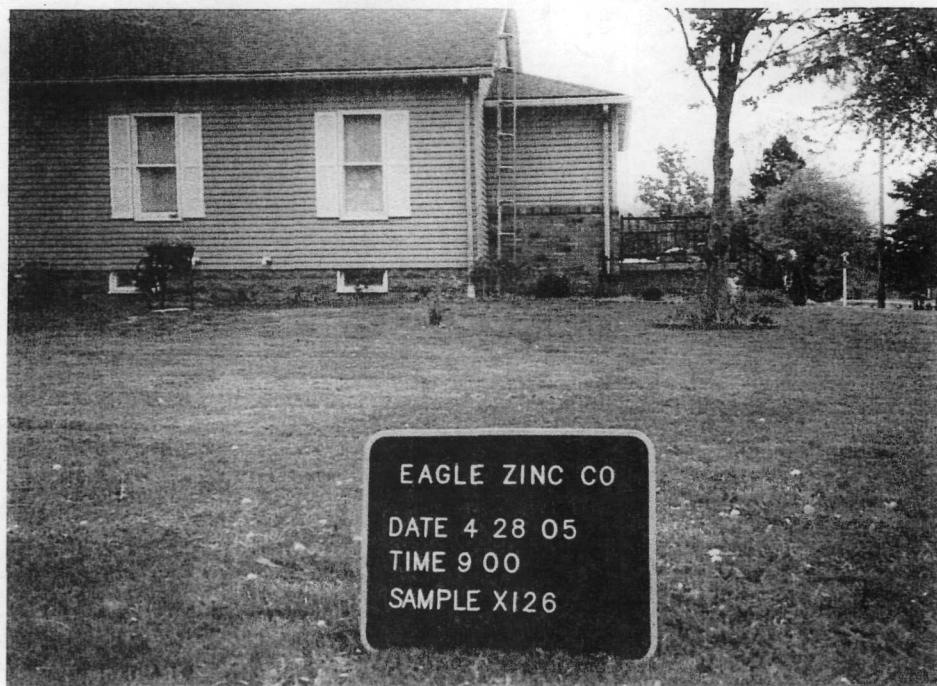
DATE: 4/28/05
TIME: 9:00
PHOTOGRAPH TAKEN BY: R. CASPER
COMMENTS: Picture taken toward: North.
Photo Number 79.
Sample X126. The sample consisted of a black silty loam collected at a depth of 0 to 2 inches.

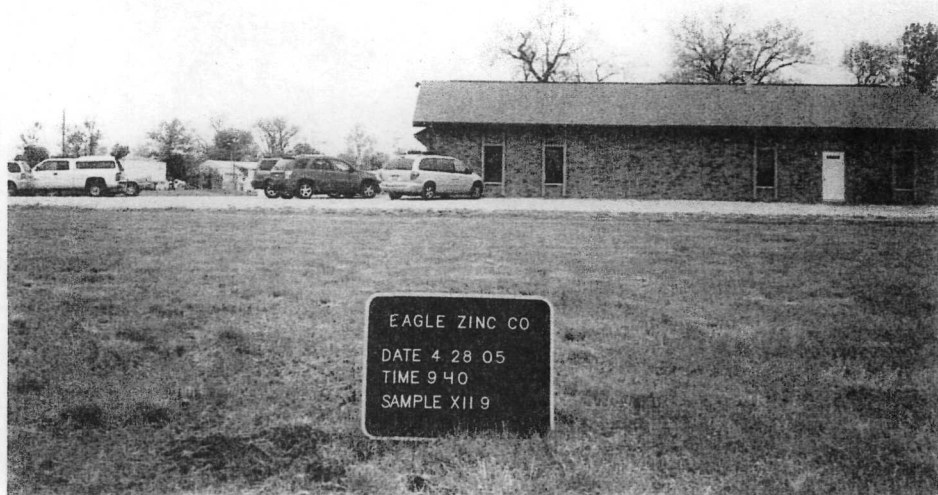
DATE: 4/28/05
TIME: 9:40
PHOTOGRAPH TAKEN BY: R. CASPER
COMMENTS: Picture taken toward: East.
Photo Number 81.
Sample X119. The sample consisted of a black silty loam collected at a depth of 0 to 2 inches.
